Uniform Mitigation Verification Inspection Form

Inspection Date: 1/18/2016		
Owner Information		
Owner Name: Tern Bay Homeowners Association		Contact Person:
Address: 545 Pinellas Bayway South, Units 401-408		Home Phone: (314) 440-6913
City: Tierra Verde	Zip: 33715	Work Phone:
County: Pinellas		Cell Phone:
Insurance Company:		Policy #:
Year of Home: 1999	# of Stories: 3	Email: p.digenova001@gmail.com

545 Pinellas Bayway South, Units 401-408

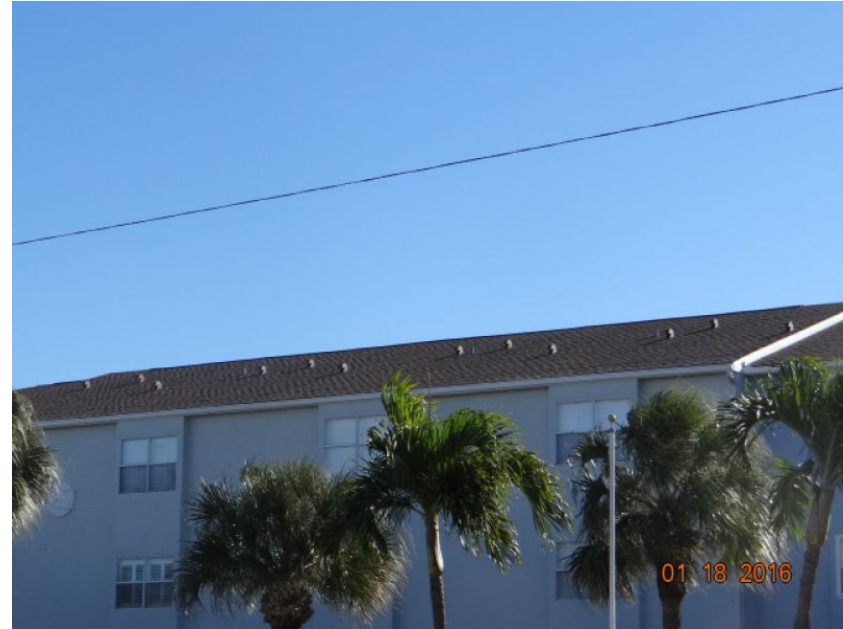
Asphalt/Fiberglass Shingle Roof Covering

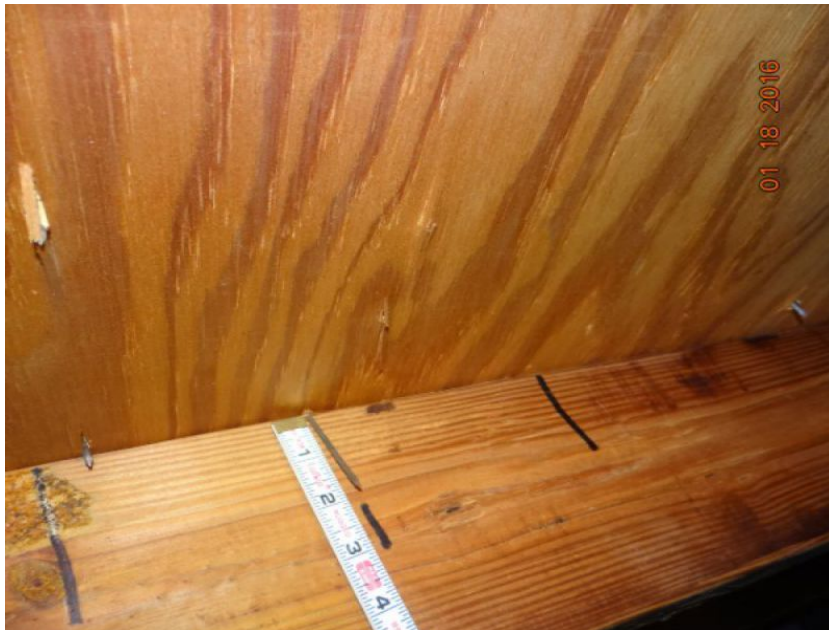
8d Nails or Greater in Size

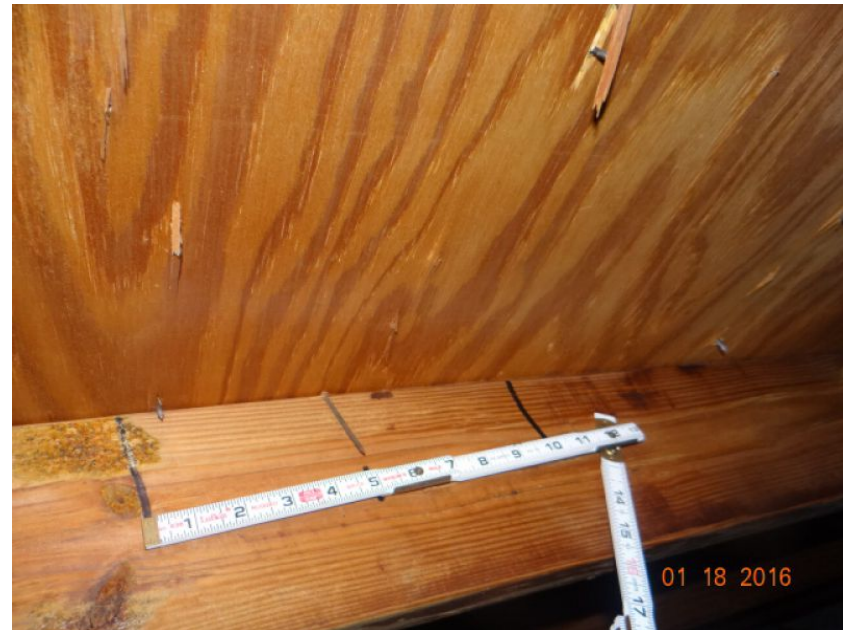
8d Nails or Greater in Size Spaced 6" Along the Edge

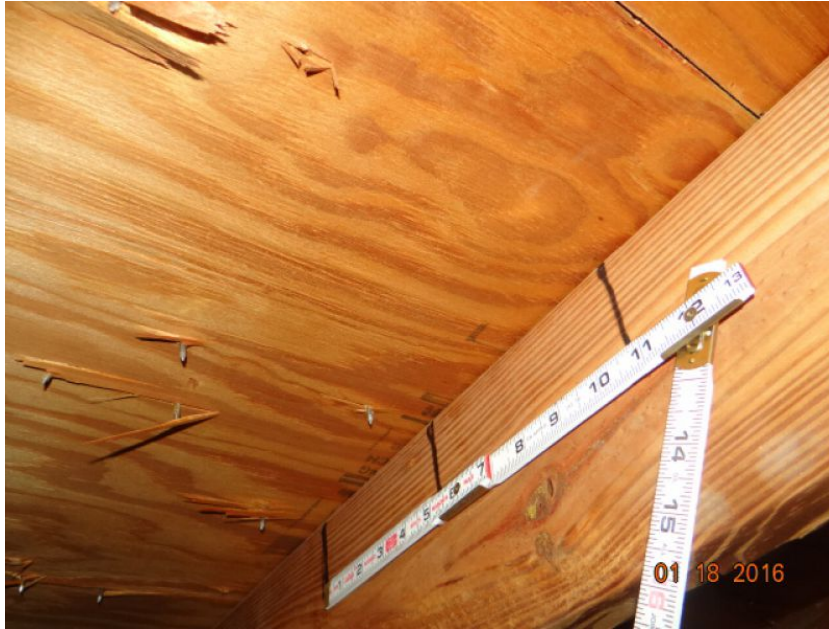
8d Nails or Greater in Size Spaced 6" in the Field

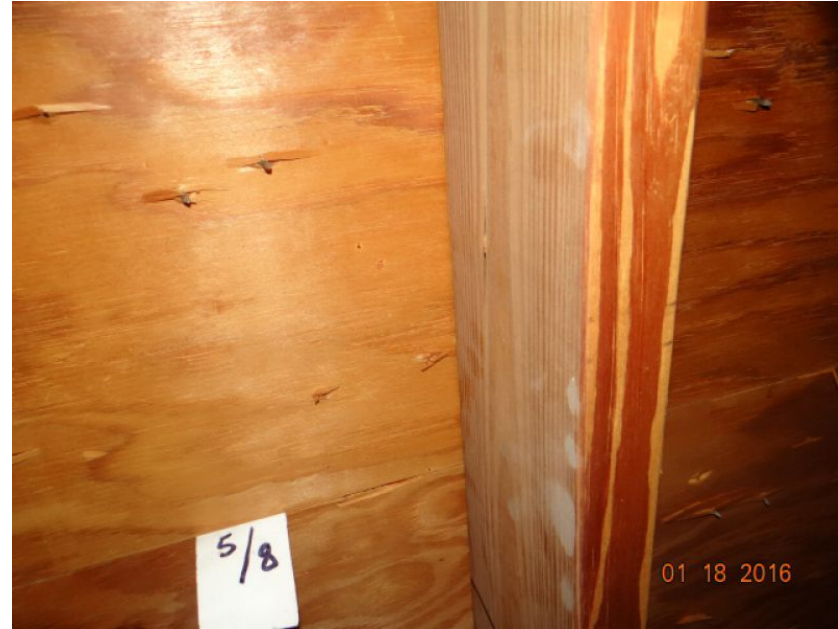
5/8" Deck Thickness Confirmed

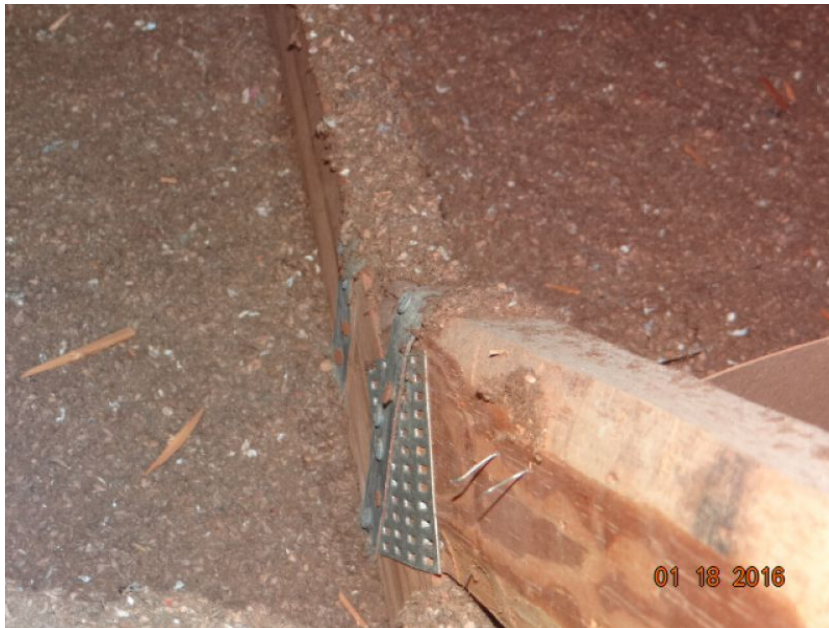
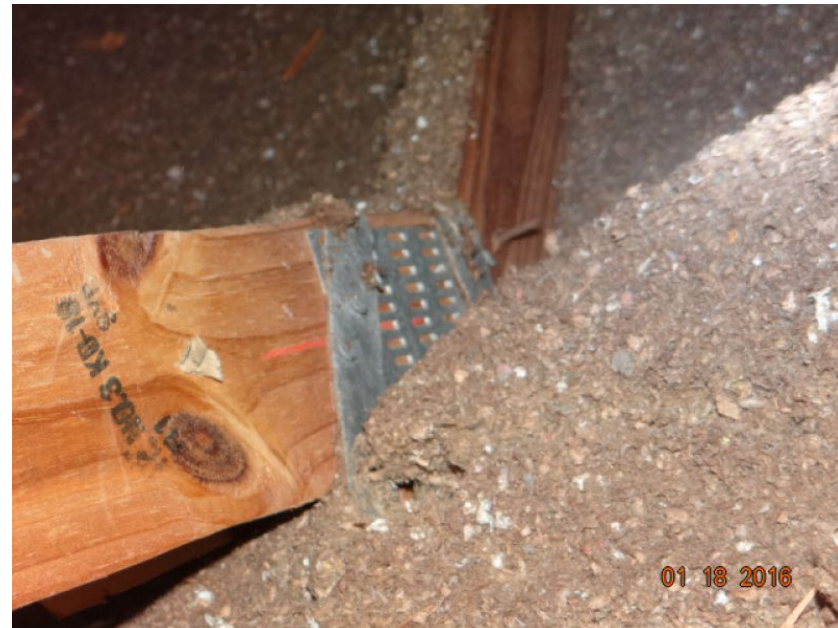
Double Wraps

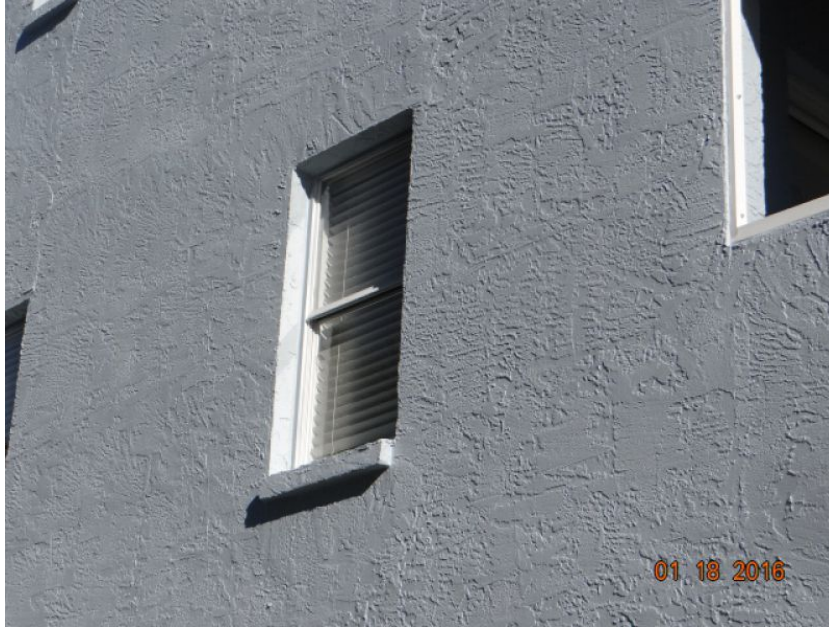
Unprotected Window

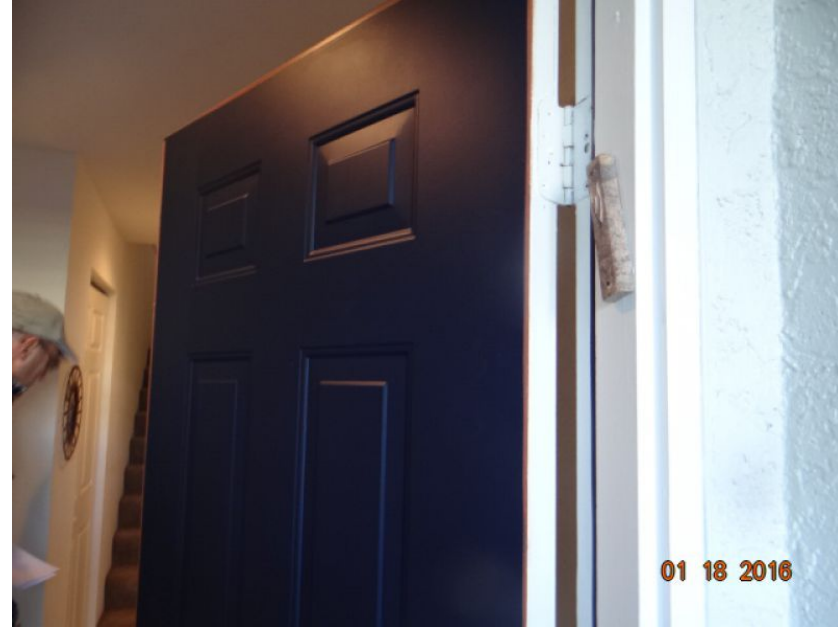
Unprotected Solid Entry Door

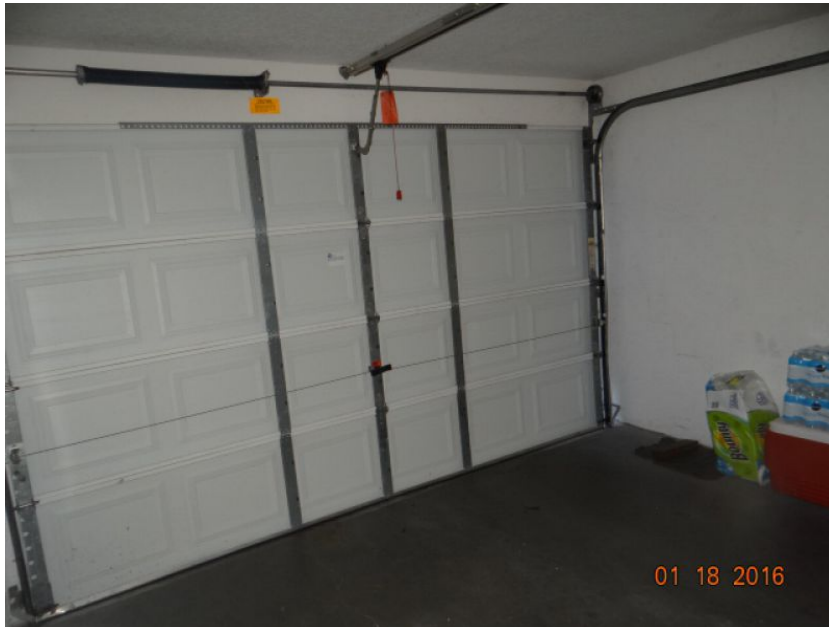
Unprotected Solid Garage Door

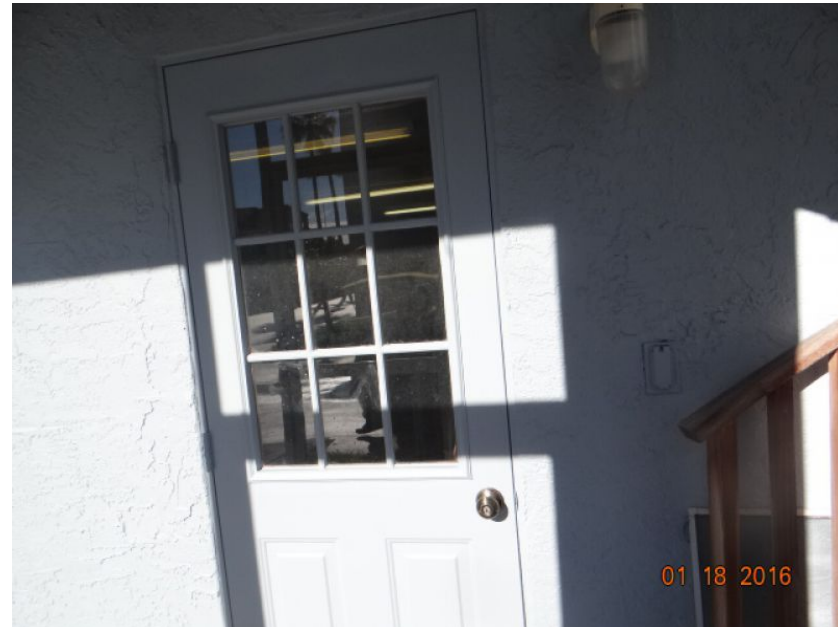
Unprotected Glazed Entry Door
