Uniform Mitigation Verification Inspection Form

Inspection Date: 1/18/2016		
Owner Information		
Owner Name: Tern Bay Homeowners Association		Contact Person:
Address: 545 Pinellas Bayway South, Units 101-109		Home Phone: (314) 440-6913
City: Tierra Verde	Zip: 33715	Work Phone:
County: Pinellas		Cell Phone:
Insurance Company:		Policy #:
Year of Home: 1999	# of Stories: 3	Email: p.digenova001@gmail.com

545 Pinellas Bayway South, Units 101-109

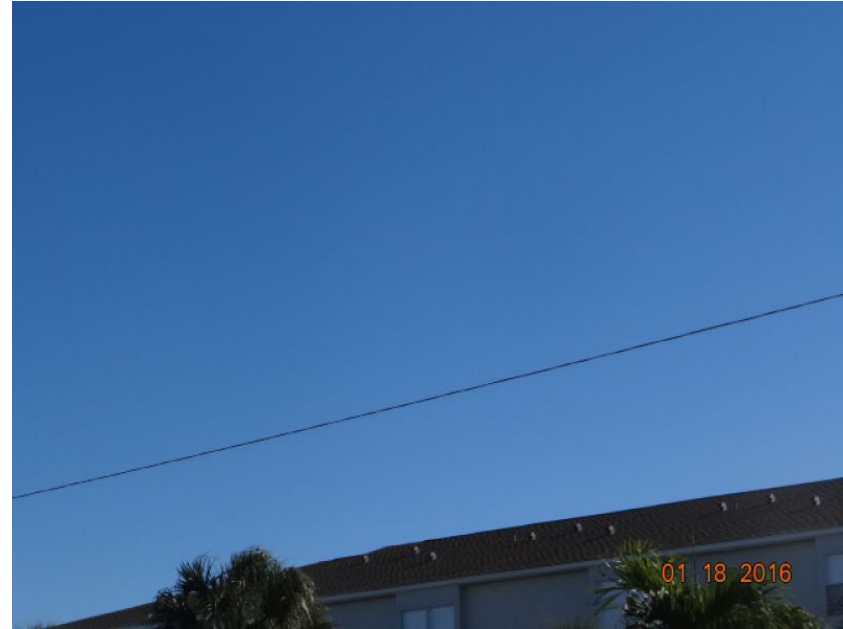
Asphalt/Fiberglass Shingle Roof Covering

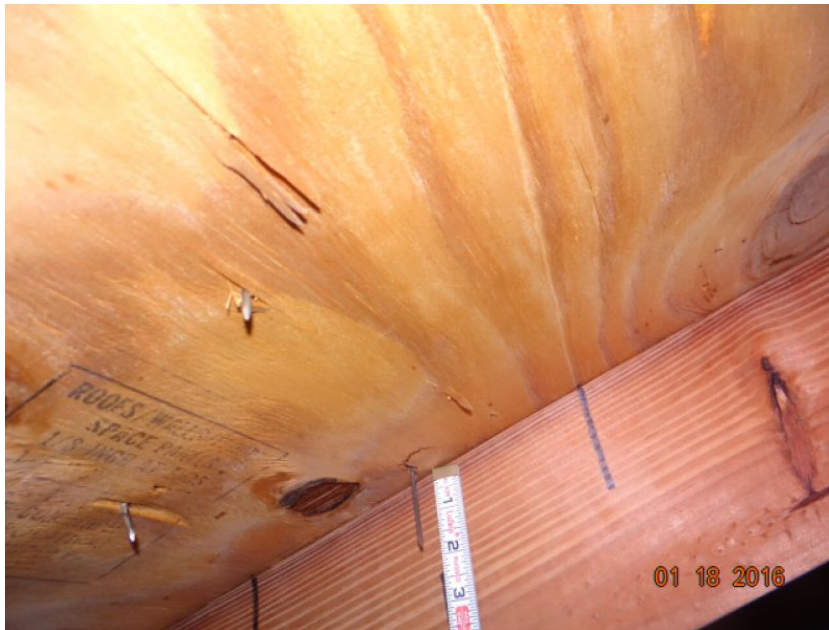
8d Nails or Greater in Size

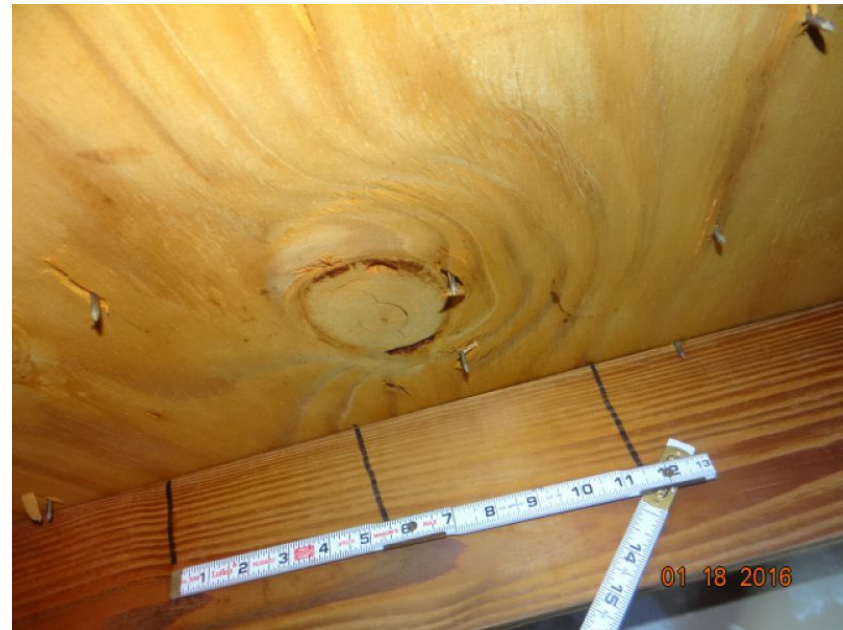
8d Nails or Greater in Size Spaced 6" Along the Edge

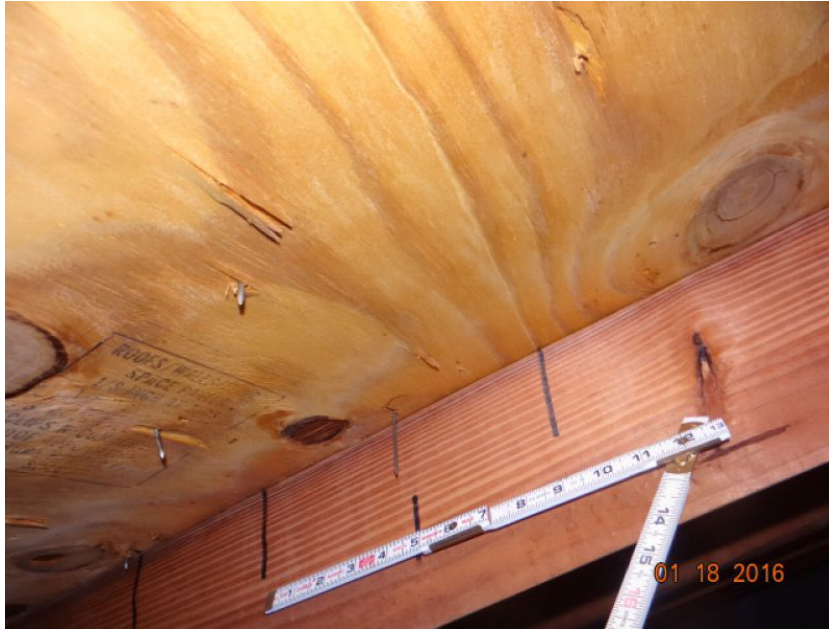
8d Nails or Greater in Size Spaced 6" in the Field

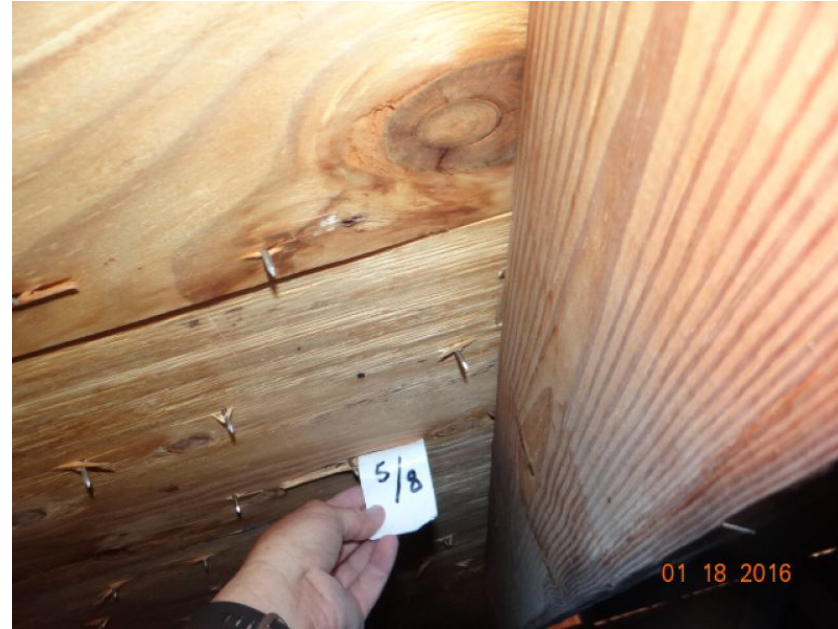
5/8" Deck Thickness Confirmed

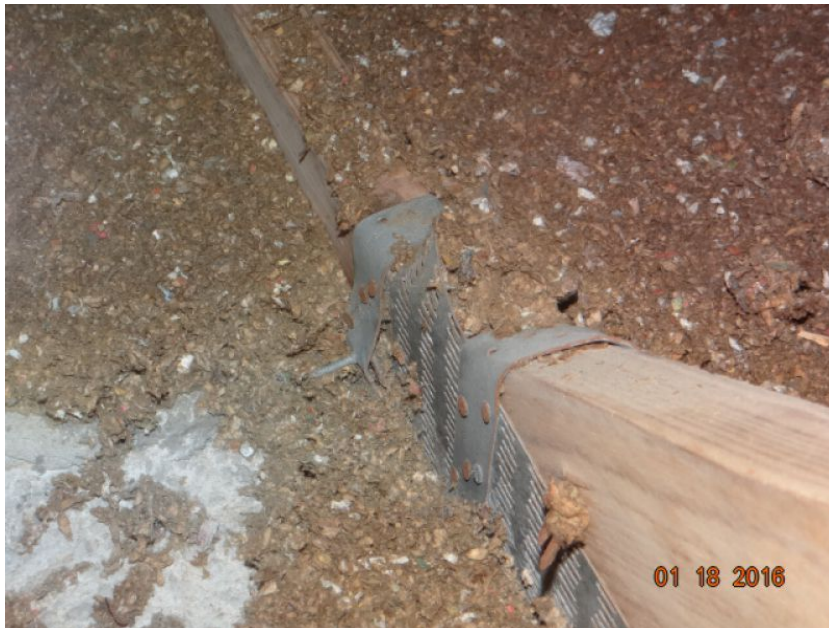
Double Wraps

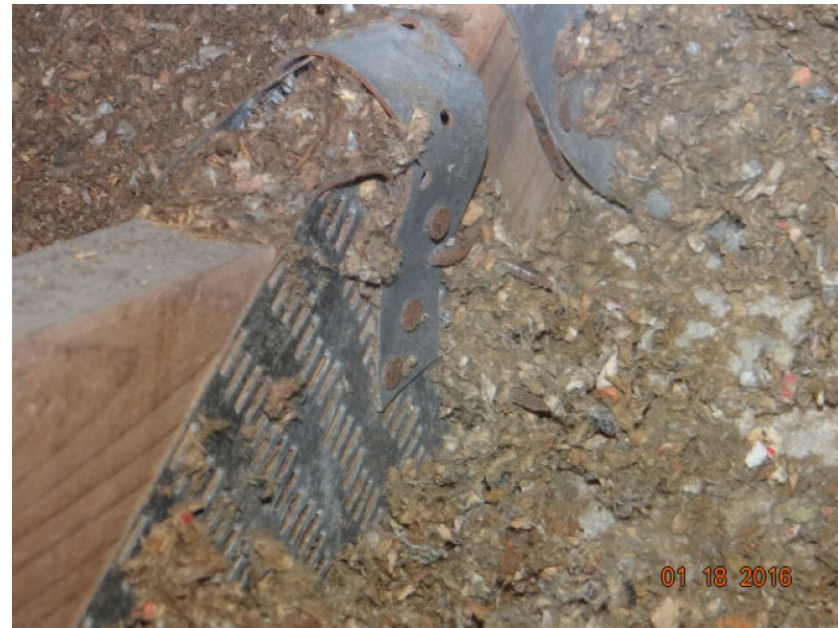
Double Wraps

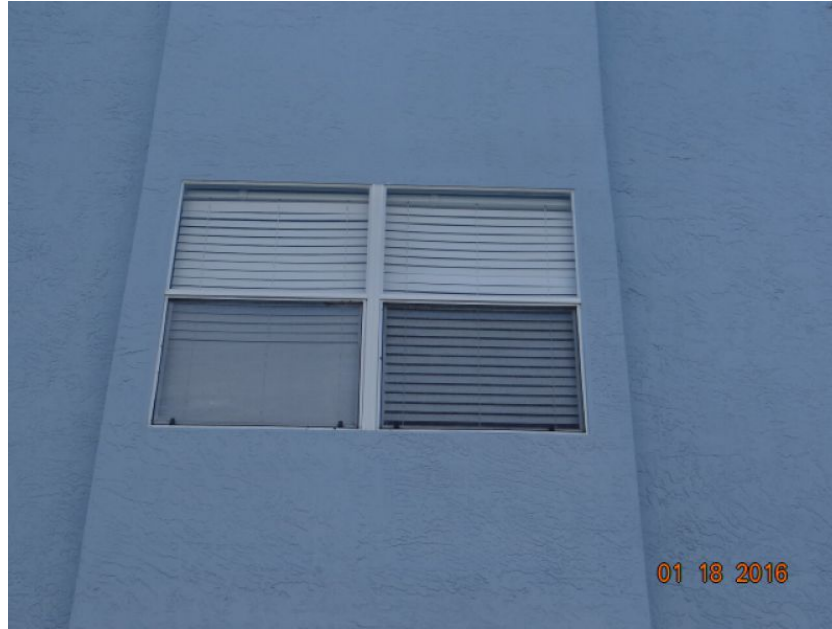
Unprotected Window

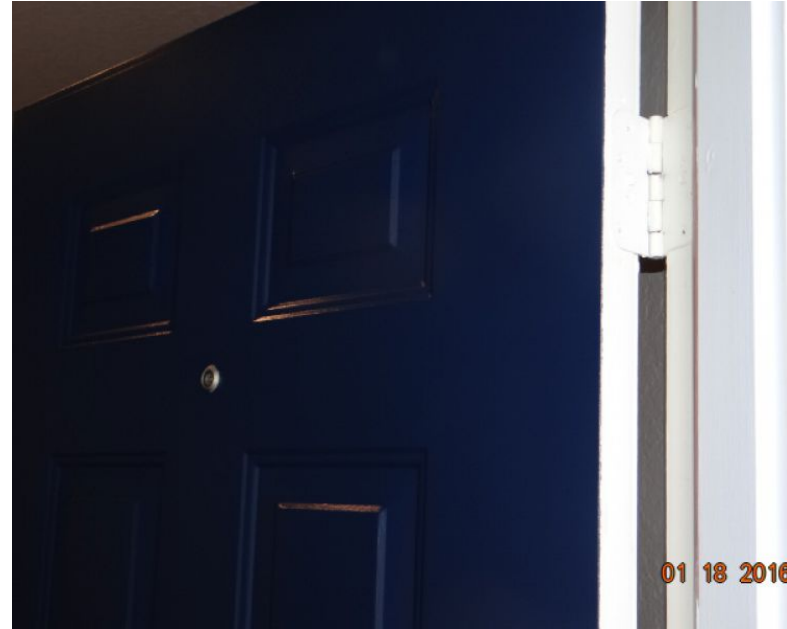
Unprotected Solid Entry Door

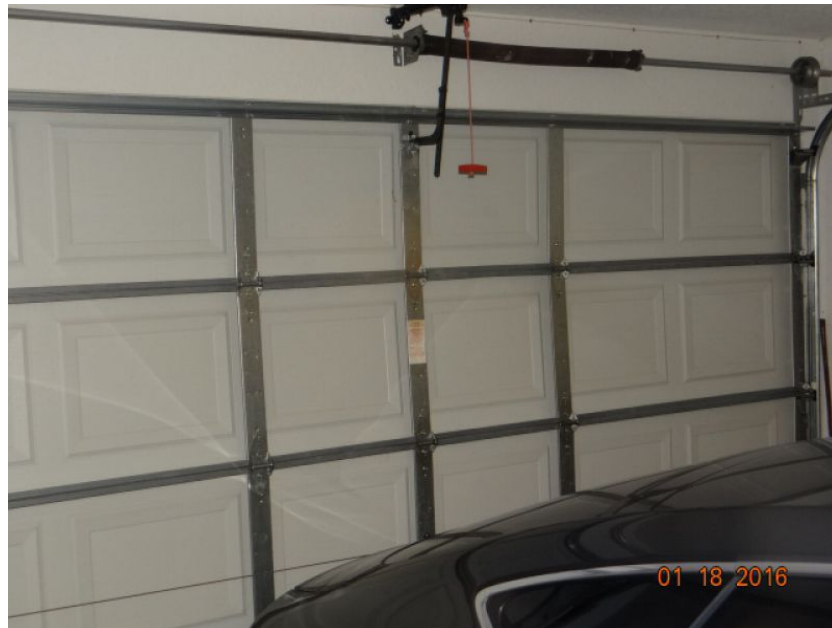
Unprotected Solid Garage Door
