Uniform Mitigation Verification Inspection Form ony of this form and any documentation provided with the insurance policy

is ioiiii allu ally u	ocumentation pro	vided with the insuran	ec poncy		
Inspection Date: 1/18/2016							
Owner Information							
•	ner Name: Tern Bay Homeowners Association lress: 545 Pinellas Bayway South, Units 301-307			Contact Person:	Home Phone: (314) 440-6913		
	ayway South, Units			Work Phone: (314)	1440-0913		
City: Tierra Verde		Zip: 33715		Cell Phone:			
County: Pinellas Insurance Company:				Policy #:			
		W CG: 2			1.0 "		
Year of Home: 1999		# of Stories:3		Email: p.digenova00	1@gmail.com		
NOTE: Any documentation used in validating the compliance or existence of each construction or mitigation attribute must accompany this form. At least one photograph must accompany this form to validate each attribute marked in questions 3 though 7. The insurer may ask additional questions regarding the mitigated feature(s) verified on this form.							
the HVHZ (Miami-D	ade or Broward cou	inties), South Florida	Building Code (SFB)

Inspectors Initials DH Property Address 545 Pinellas Bayway South, Units 301-307 Tierra Verde, FL 33715

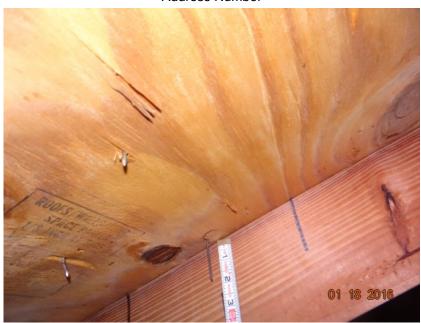
8d Nails or Greater in Size

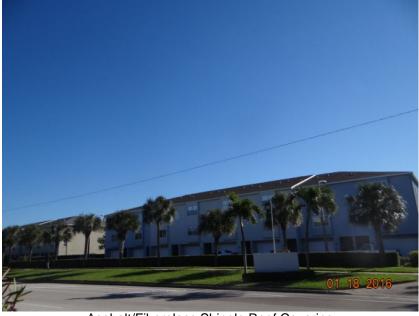
Asphalt/Fiberglass Shingle Roof Covering

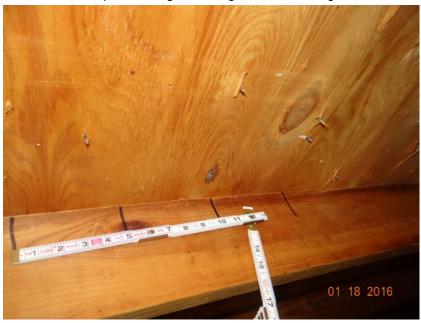
8d Nails or Greater in Size Spaced 6" Along the Edge

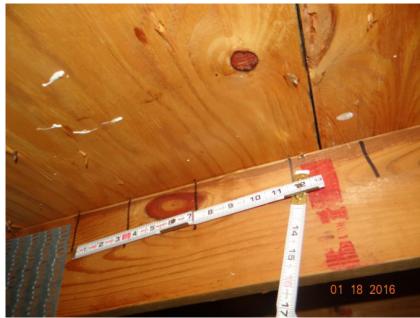
8d Nails or Greater in Size Spaced 6" in the Field

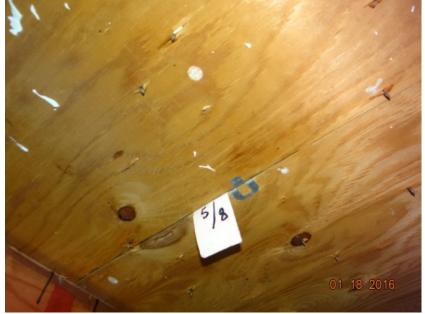
5/8" Deck Thickness Confirmed

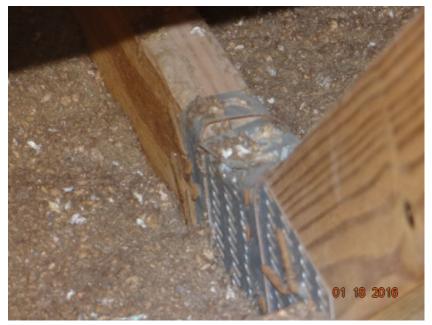
Double Wraps

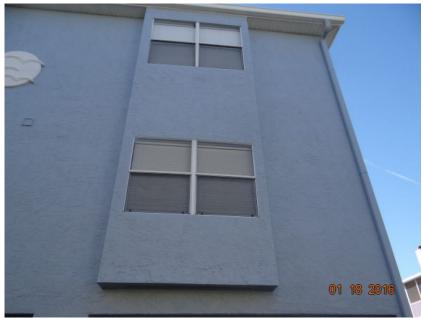
Unprotected Window

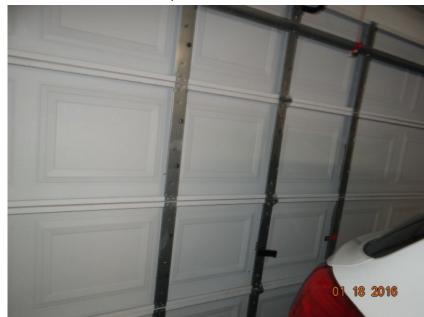
Unprotected Solid Garage Door

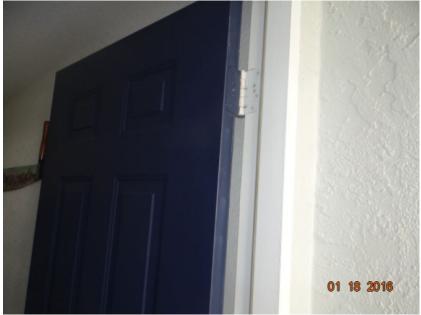
Unprotected Solid Entry Door
